FAULT TREE ANALYSIS AND ALTERNATIVE CONFIGURATIONS OF ANGLE OF ATTACK (AOA) SENSORS AS PART OF MANEUVERING CHARACTERISTICS AUGMENTATION SYSTEM (MCAS)

Magdi Ragheb
Department of Nuclear, Plasma and Radiological Engineering
University of Illinois at Urbana-Champaign,
216 Talbot Laboratory, 104 South Wright Street,
Urbana, Illinois 61801, USA.
mragheb@illinois.edu, <https://www.mragheb.com>

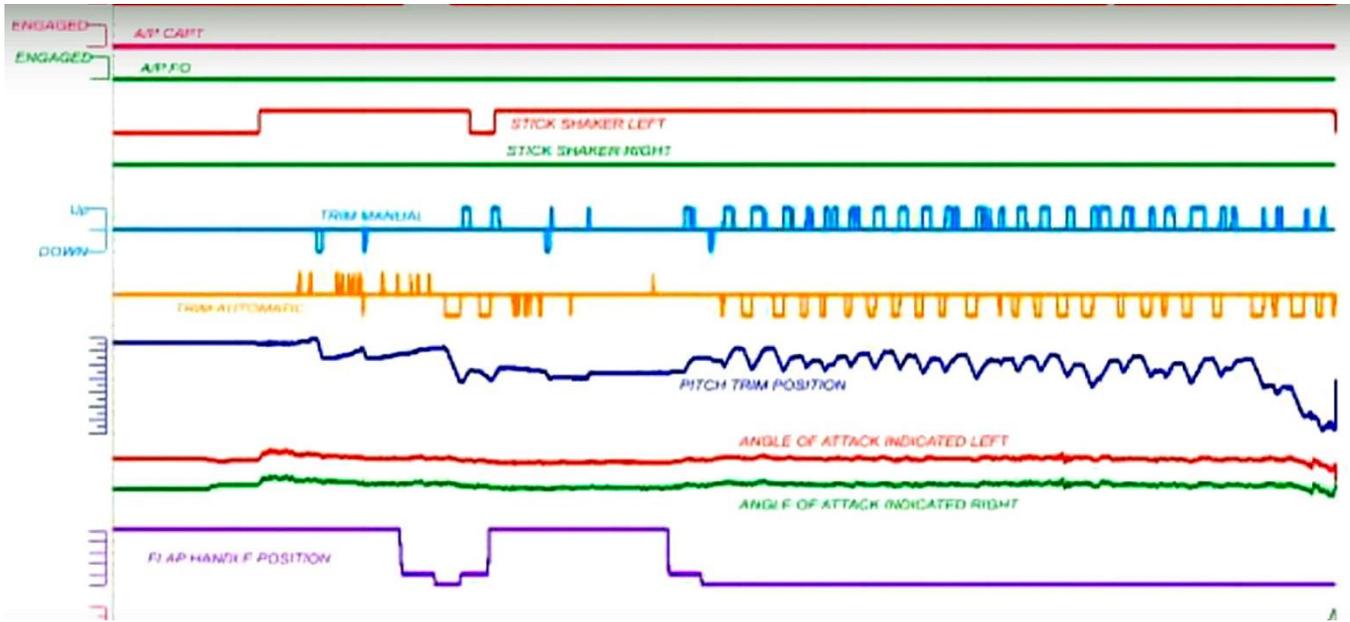
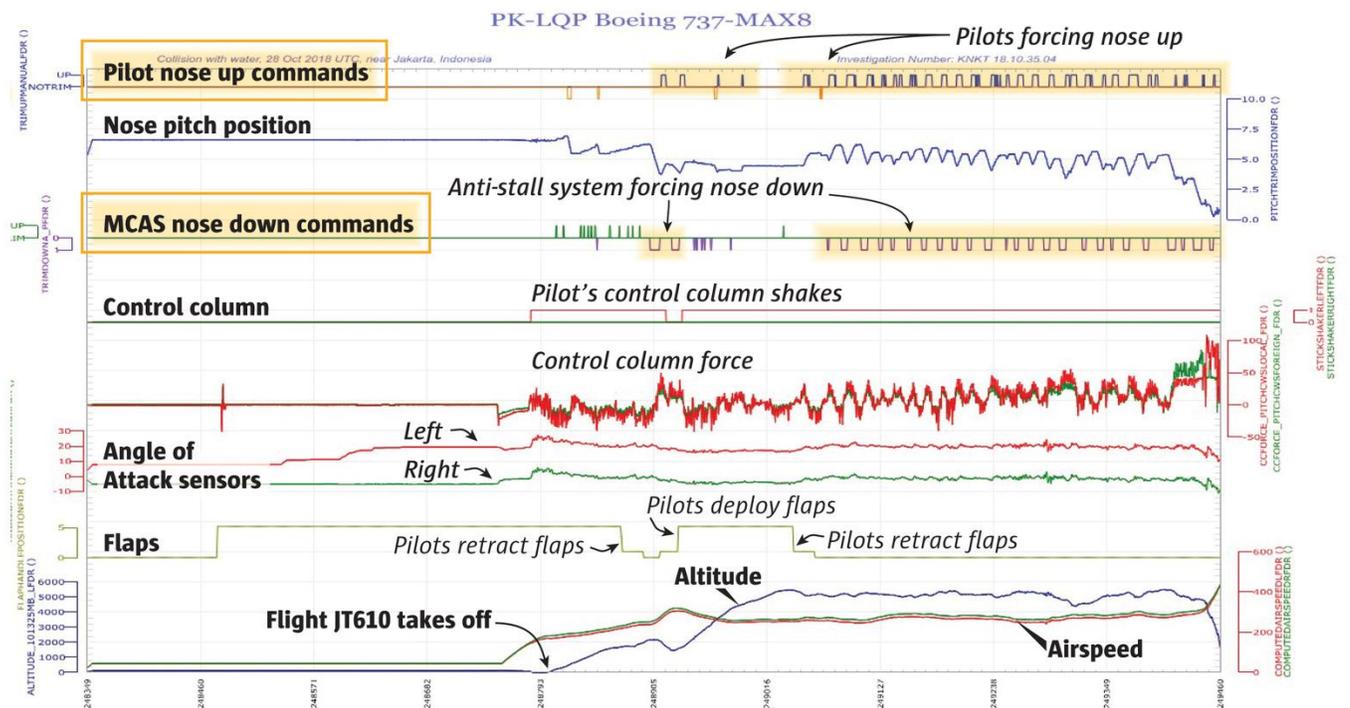
Figure 9. The MCAS system on the Lion Air accident forced the nose of Lion Air JT610 down 26 times in 10 minutes before loss of control by the crew causing a sea crash.

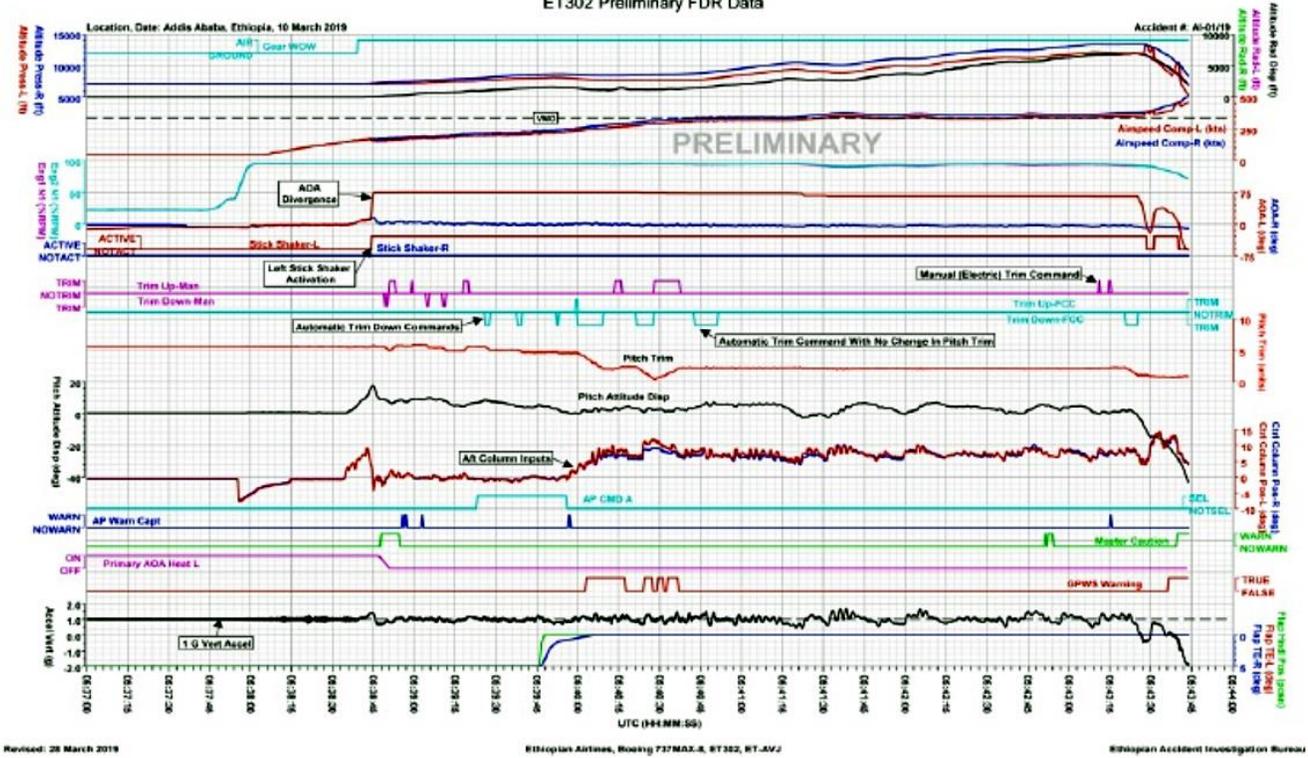
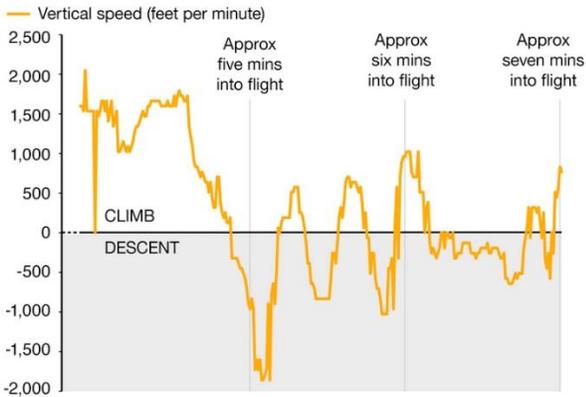
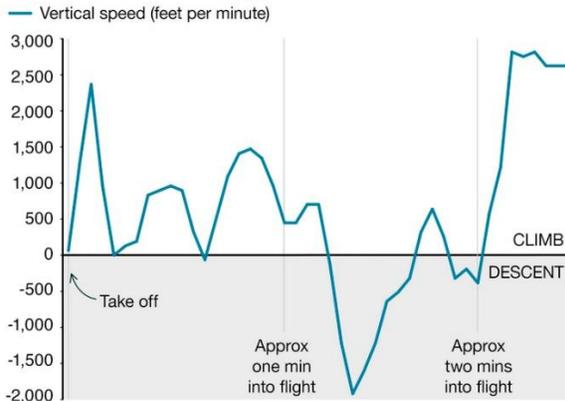
ET302 Preliminary FDR Data

Figure 10. ET302 FDR data [7]. In most aircraft pulling on the yoke will totally disengage the auto trim and the pilots obtain control. MCAS engages in 10 sec bursts and will only disengage for 5 sec on pulling back the yoke then engages again. Vertical speed of aircraft from radar data suggest similar behavior.

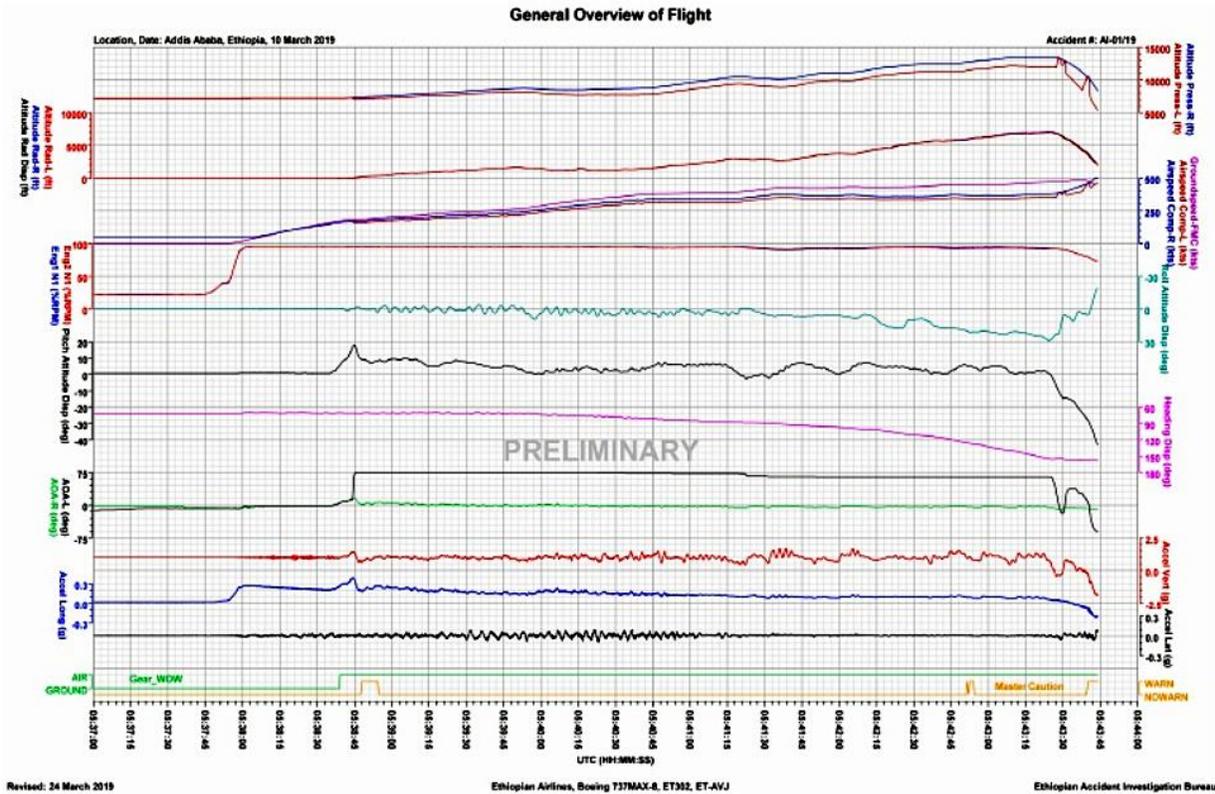
Figure 11. ET302 General Overview of flight. “On March 10, 2019, at 05:38 UTC, Ethiopian Airlines flight 302, Boeing 737-8(MAX), ET-AVJ, took off from Addis Ababa Bole Int. Airport bound to Nairobi, Kenya Jomo Kenyatta Int. Airport. Shortly after takeoff, the Angle of Attack sensor recorded value became erroneous and the left stick shaker activated and remained active until near the end of the flight. In addition, the airspeed and altitude values from the left air data system began deviating from the corresponding right side values. Due to flight control problems, the Captain was unable to maintain the flight path and requested to return back to the departure airport. The crew lost control of the aircraft which crashed at 5: 44 UTC 28 NM South East of Addis Ababa near Ejere village. [67]”

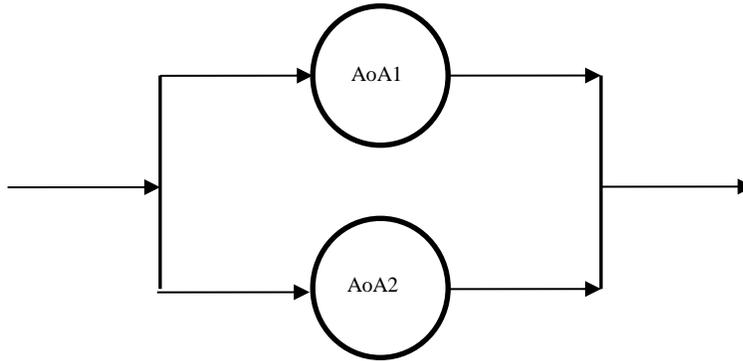
This is a substantial decrease in the failure probability, an increase in reliability and expresses the expected reward of using redundancy.

Figure 20. Physical configuration of two parallel AoA sensors.

Since existing platforms in service already possess two sensors; one on each side of the cockpit, a reconfiguration along this line would substantially reduce the failure probability and allow continued safe operation in association with enhanced maintenance and training protocols.

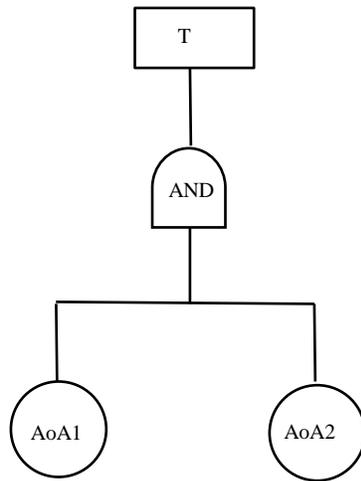
$$\begin{aligned} P(T) &= P(AoA1) \times P(AoA2) \\ &= 10^{-2} \times 10^{-2} \\ &= 10^{-4} \end{aligned}$$

Figure 21. Fault Tree of two parallel AoA sensors configuration.

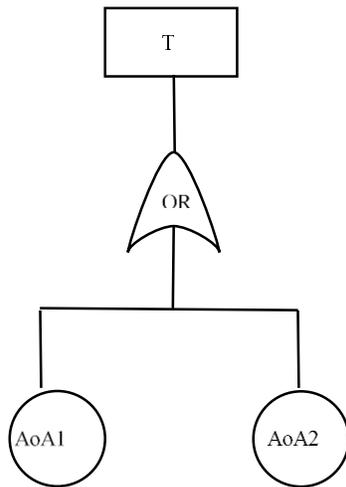
Figure 25. Fault Tree of two serial AoA sensors configuration.

Such a configuration is not recommended since it even doubles the probability of failure and totally defeats the concept of using two sensors for the purpose of redundancy and gives a false sense of security even though its failure probability is double that of using a single sensor.

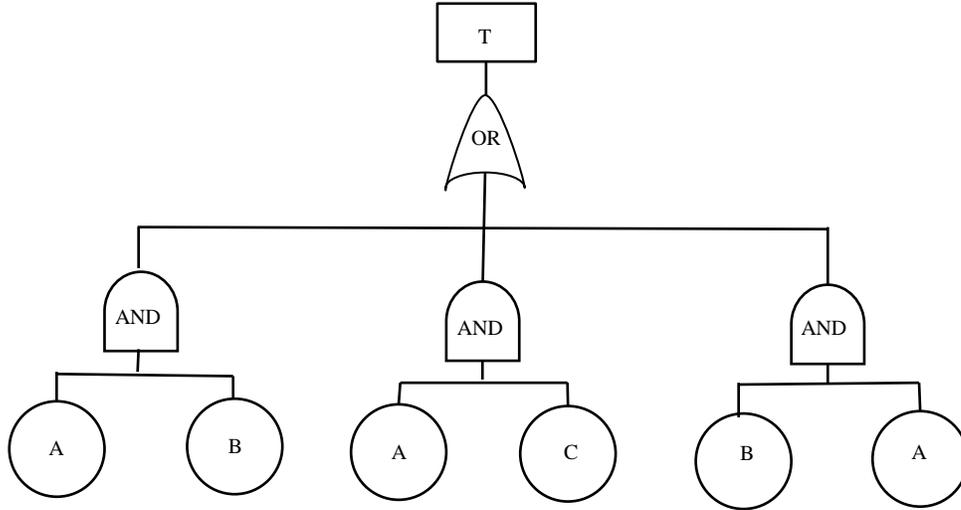
Such a logic allows the choice in the displays and control actions to polling and choosing the most plausible two readings out of three sensors, possibly eliminating any conflicting or suspect pair of readings by the sensors that have a large discrepancy implying a possible defective sensor.

Figure 27. Fault Tree of Two-out-of-three logic sensors configuration.

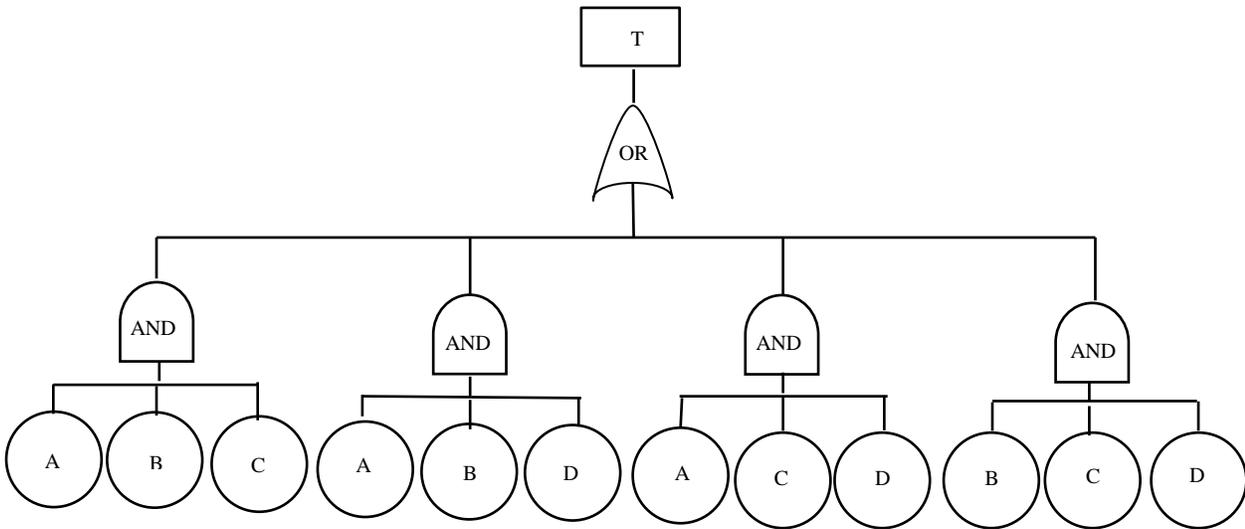
Figure 28. Fault Tree of Three-out-of-four logic sensors configuration.

This would indeed lead to a substantial decrease in the failure probability and a spectacular increase in the level of safety.
