FAULT TREE ANALYSIS AND ALTERNATIVE CONFIGURATIONS OF ANGLE OF ATTACK (AOA) SENSORS AS PART OF MANEUVERING CHARACTERISTICS AUGMENTATION SYSTEM (MCAS)

Magdi Ragheb
Department of Nuclear, Plasma and Radiological Engineering
University of Illinois at Urbana-Champaign,
216 Talbot Laboratory, 104 South Wright Street,
Urbana, Illinois 61801, USA.
mragheb@illinois.edu, <https://www.mragheb.com>

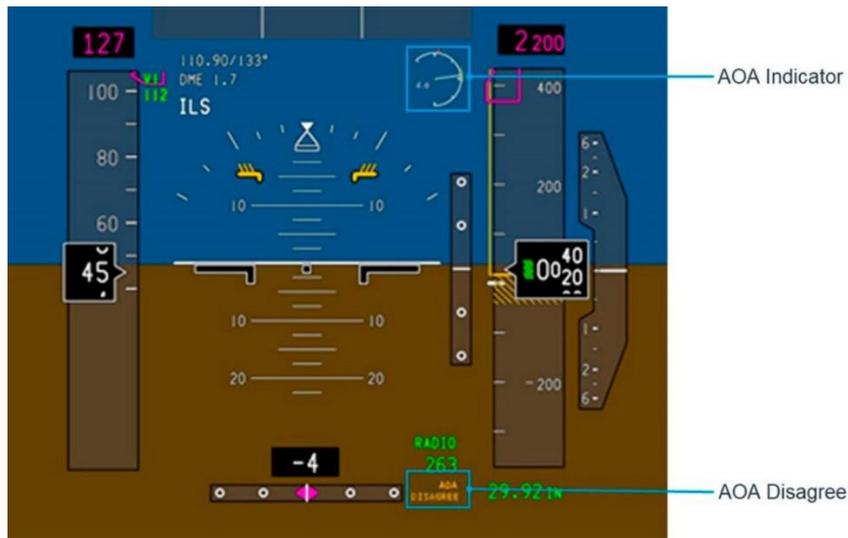
Figure 1. Boeing new enhanced flight deck display showing AoA sensor settings. “The AoA (Angle of Attack) indicator provides supplementary information to the flight crew. The AoA disagree alert provides additional context for understanding the possible cause of air speed and altitude differences between the pilot’s and first officer’s displays.”

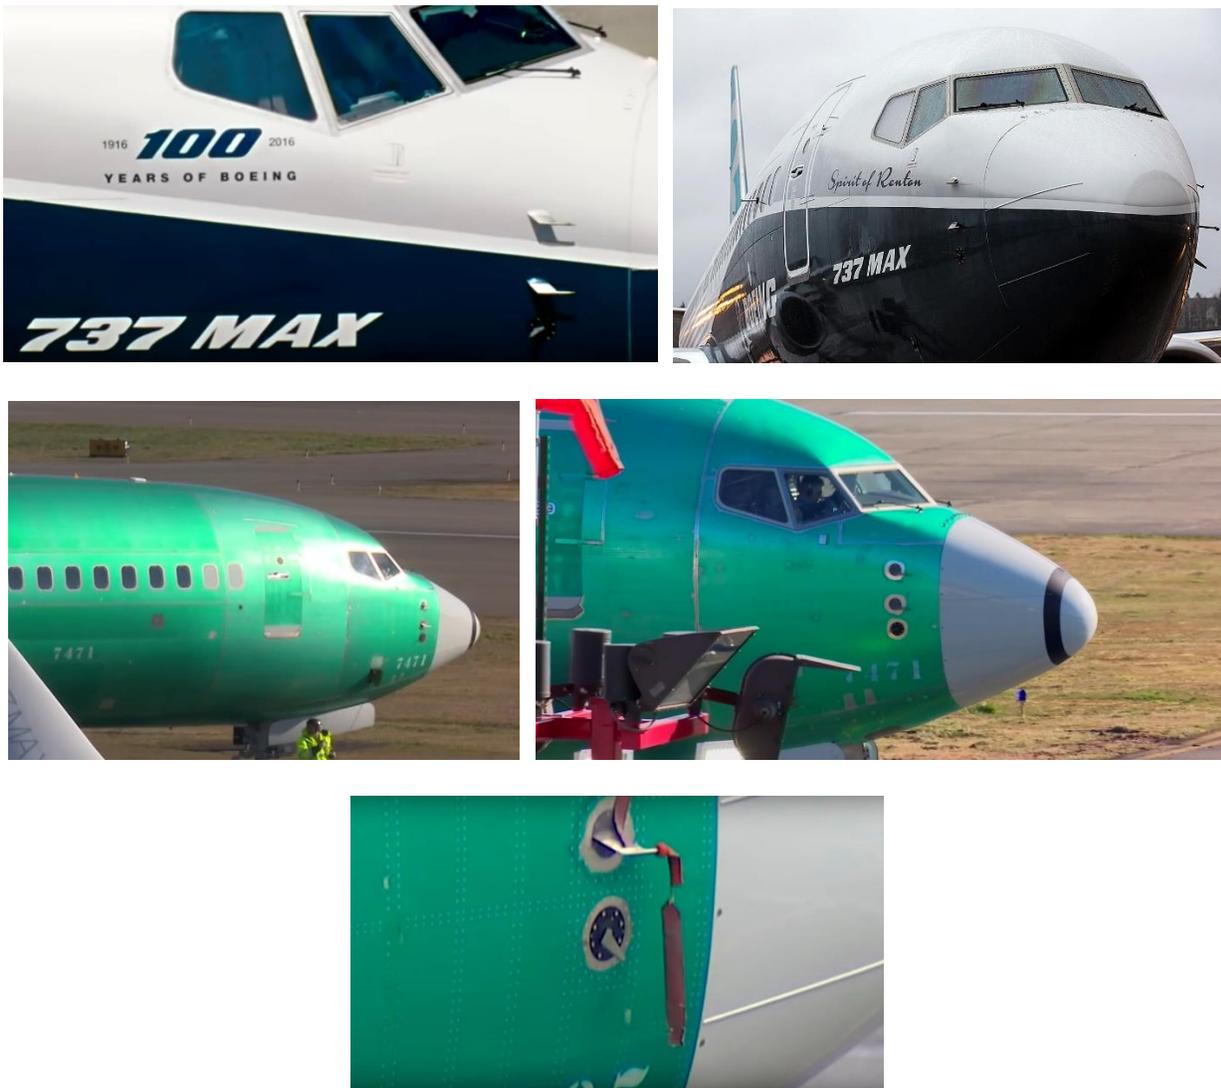
Figure 3. Angle of Attack AoA sensor and Pitot tubes on side of the cockpit. The AoA sensor reading triggers the MCAS system, as well as the stick shaker and the stall warning.

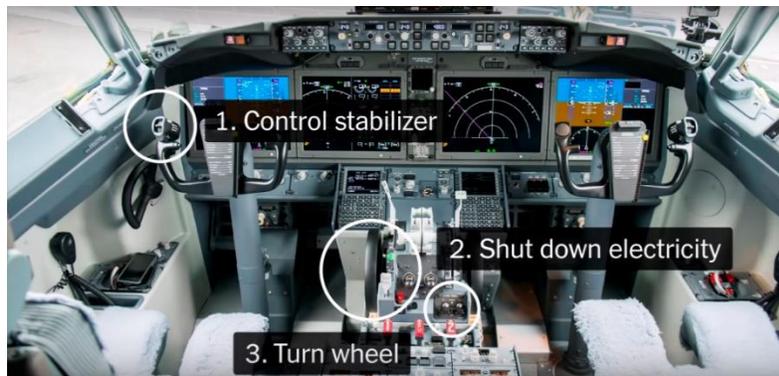
Figure 17. Steps in overriding MACS system.

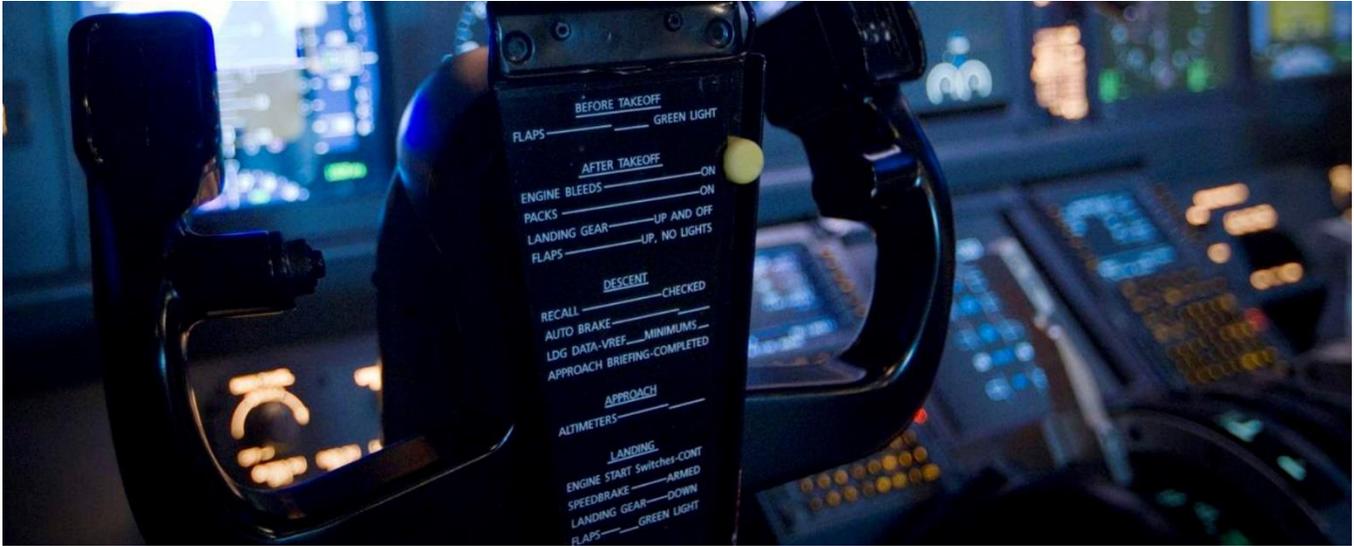
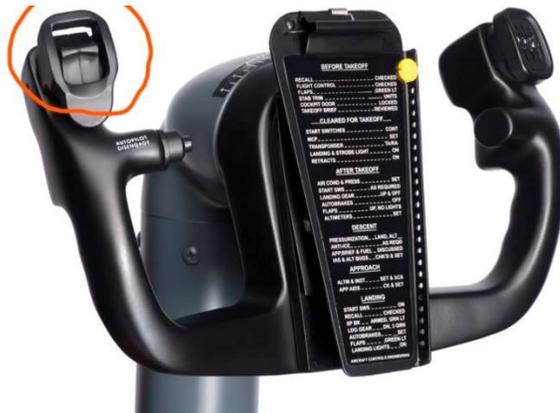
Figure 18. Manual control switches on yoke. The trim system under MCAS is not stopped by simply moving the control yoke, it must be disengaged.

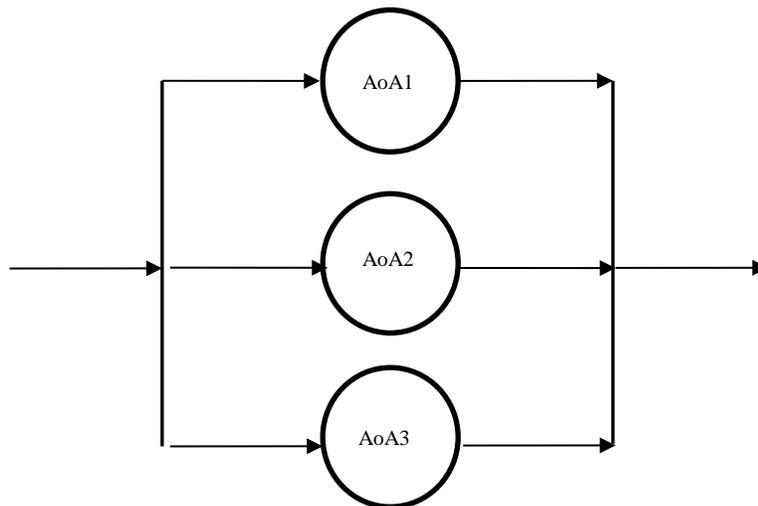
This is an even more dramatic decrease in the failure probability, an increase in reliability and a high reward for using redundancy.

Figure 22. Physical configuration of three parallel AoA sensors.

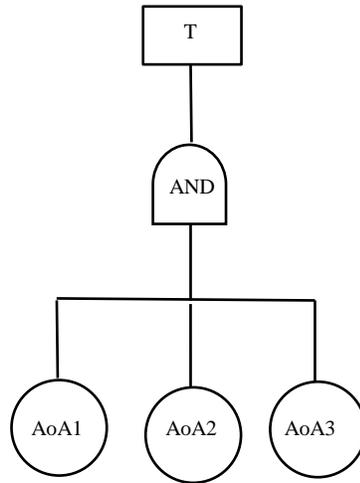
$$\begin{aligned} P(T) &= P(AoA1) \times P(AoA2) \times P(AoA3) \\ &= 10^{-2} \times 10^{-2} \times 10^{-2} \\ &= 10^{-6} \end{aligned}$$

Figure 23. Fault Tree of three parallel AoA sensors configuration.

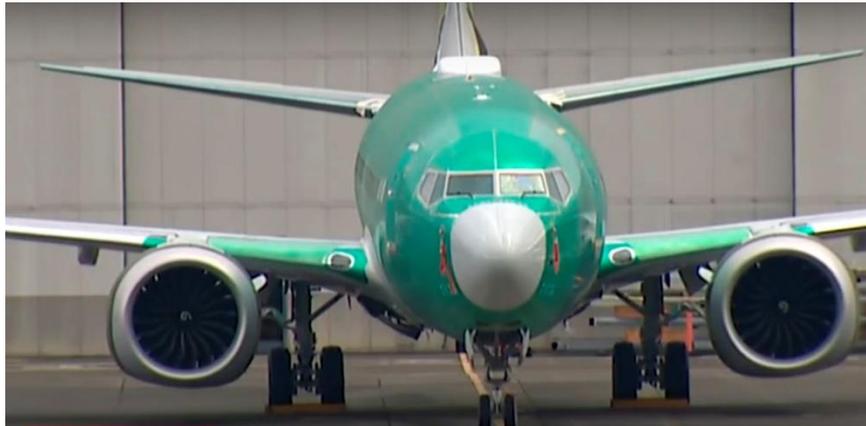
Figure 26. Front view of plane equipped with AoA sensor on the left side of cockpit.

What if one single sensor is used or two sensors are used interchangeably from one trip to another. A maintenance error where one sensor is tested only once, and not twice. would not only possibly test the non-defective sensor if the setting has been switched after a trip, but also restore the defective sensor for use on the next trip. In that case, one sensor or the other is used implying an OR gate in the Fault Tree diagram, and the Boolean Expression is:

Such a configuration is not recommended since it even doubles the probability of failure and totally defeats the concept of using two sensors for the purpose of redundancy and gives a false sense of security even though its failure probability is double that of using a single sensor.
